Case 362 : Narrative

Case Vehicle (A): 1998 Chevrolet
Type: Venture, Sport van
Driver: 35-year-old female
CDC: 12-FZEW-4

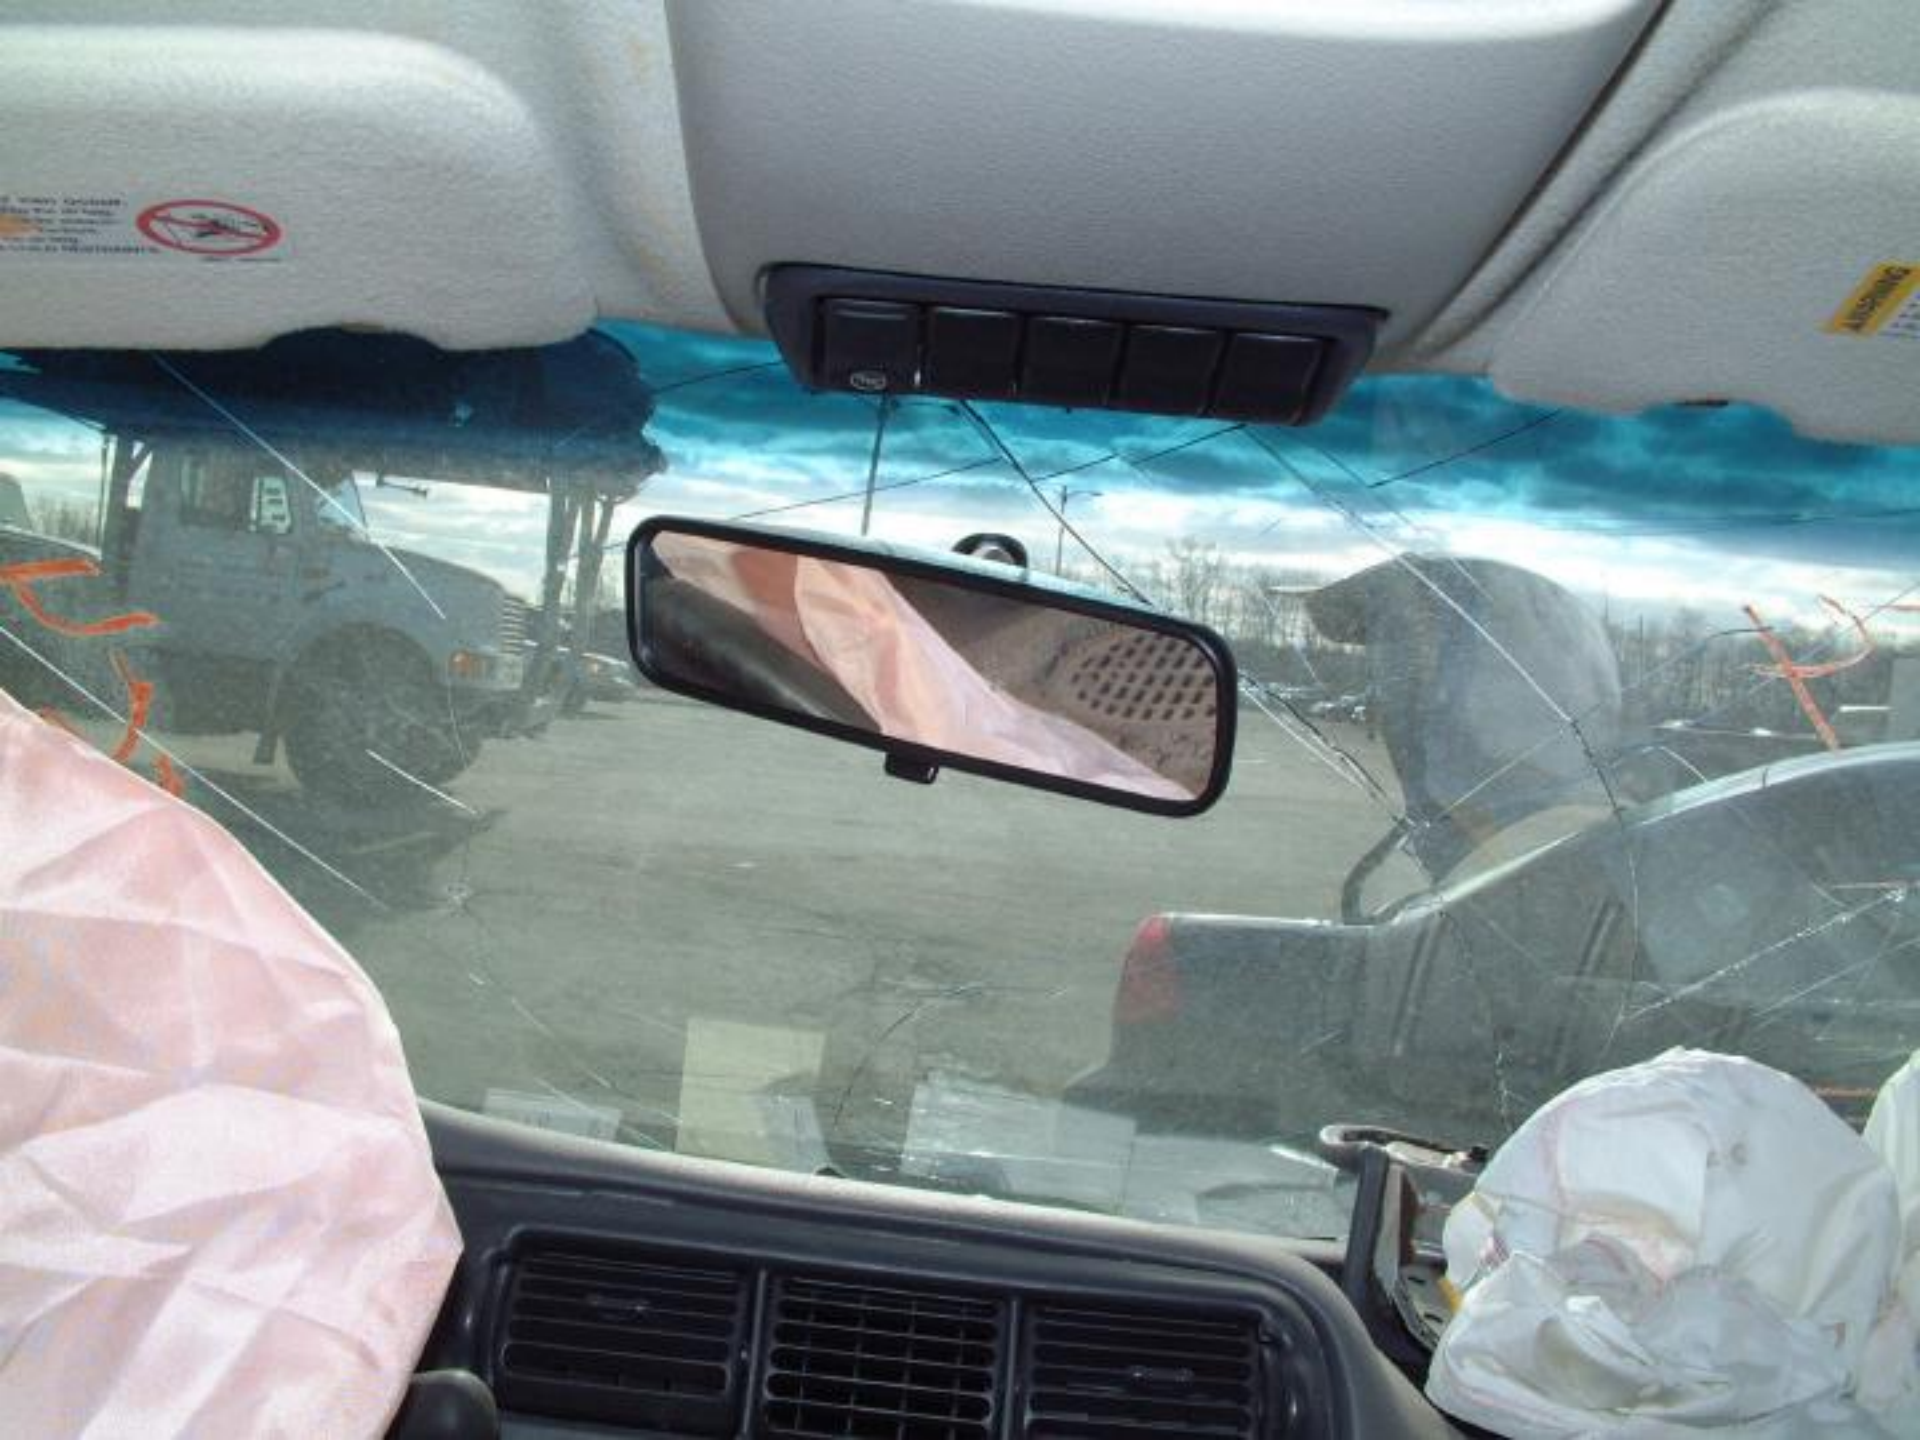
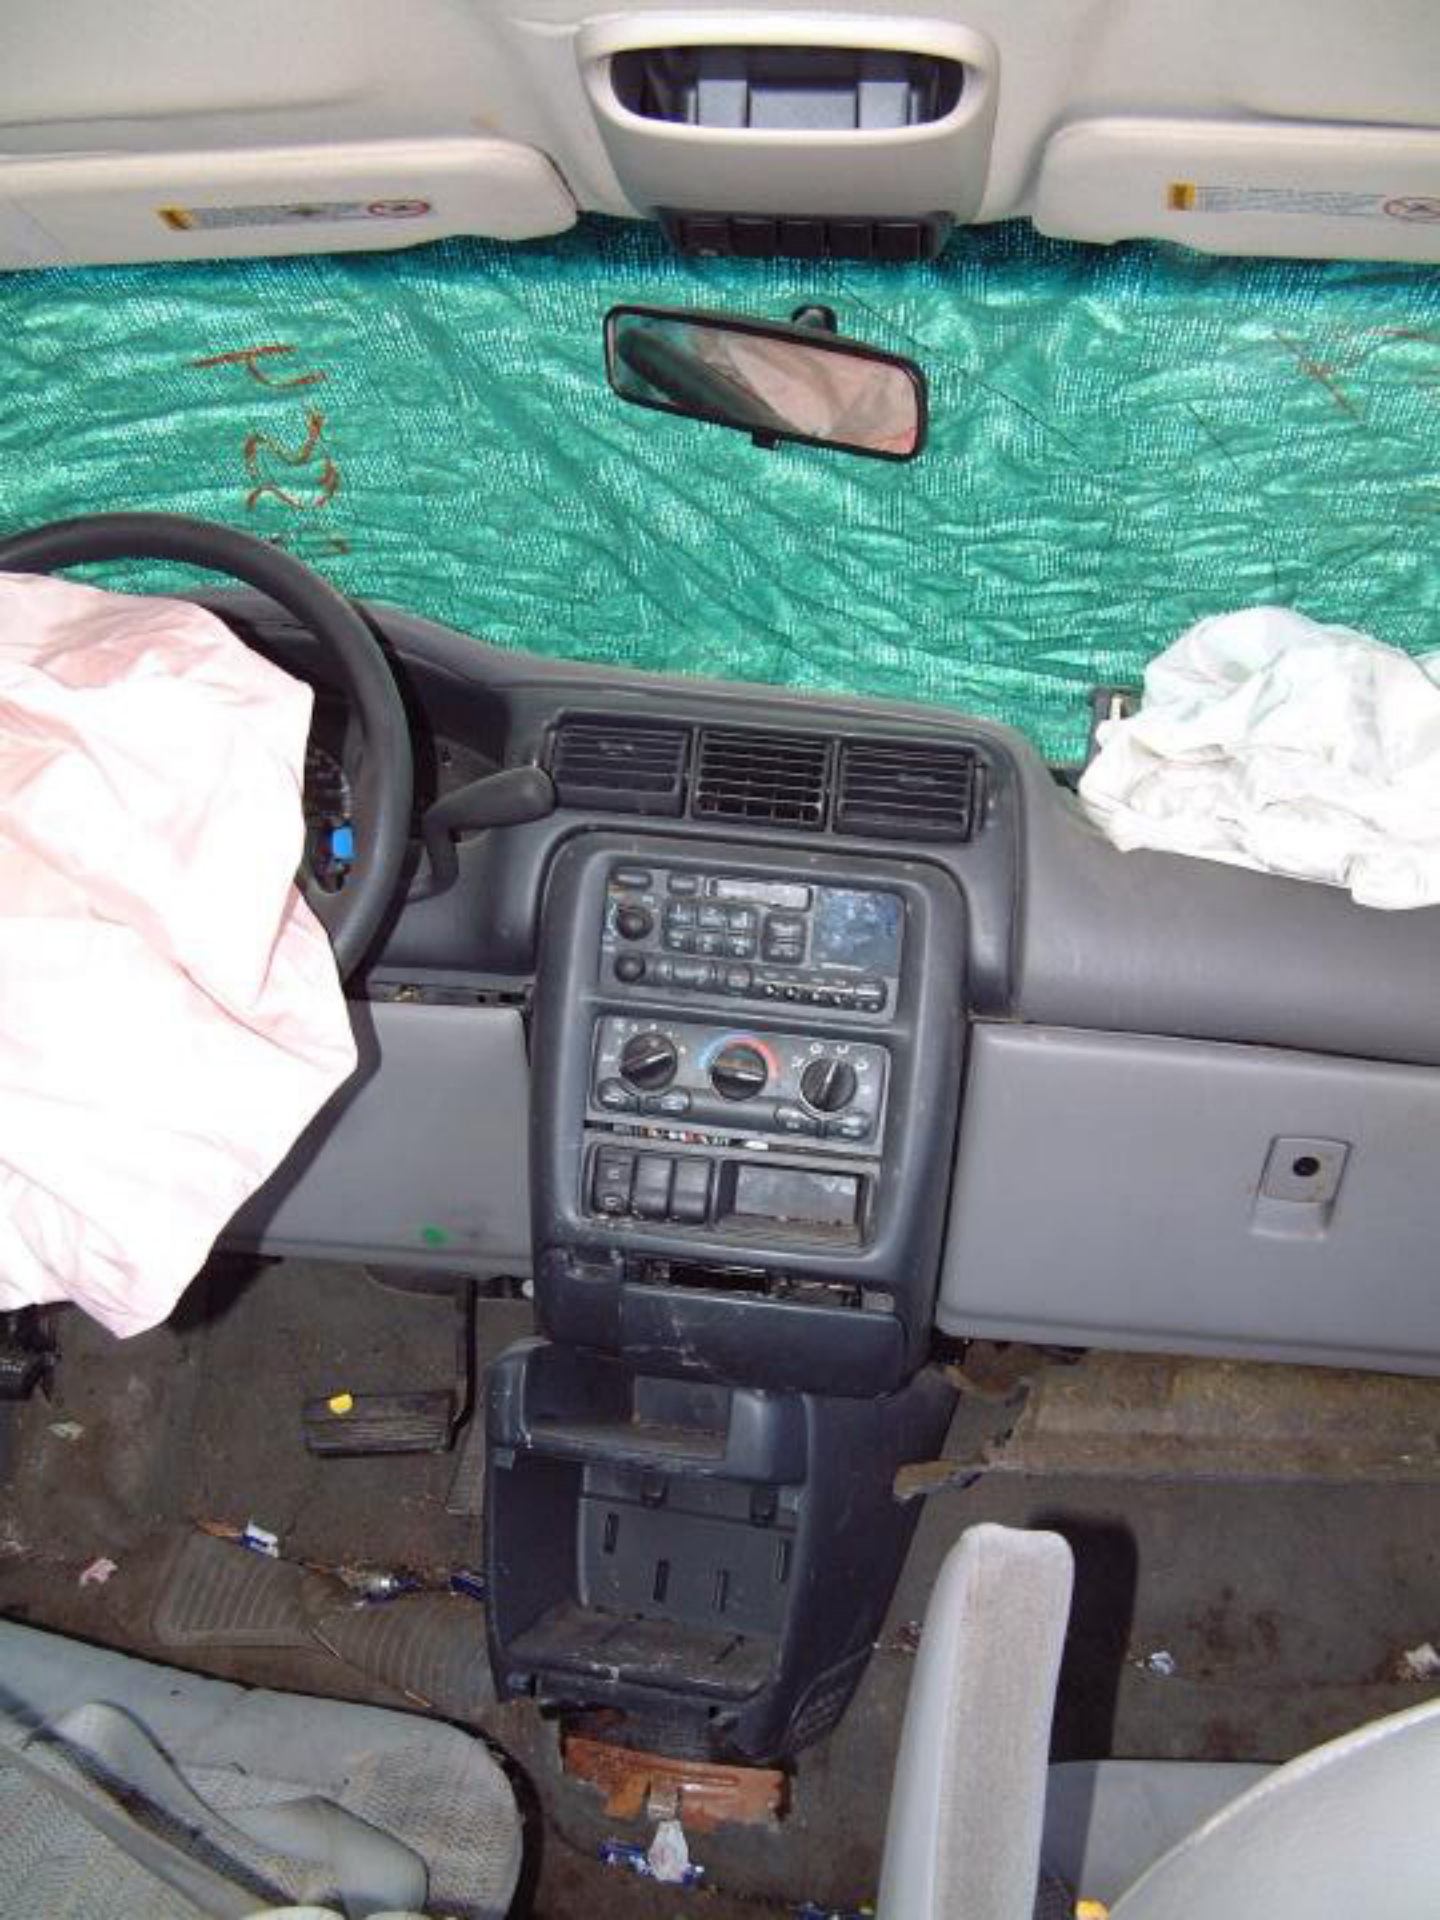
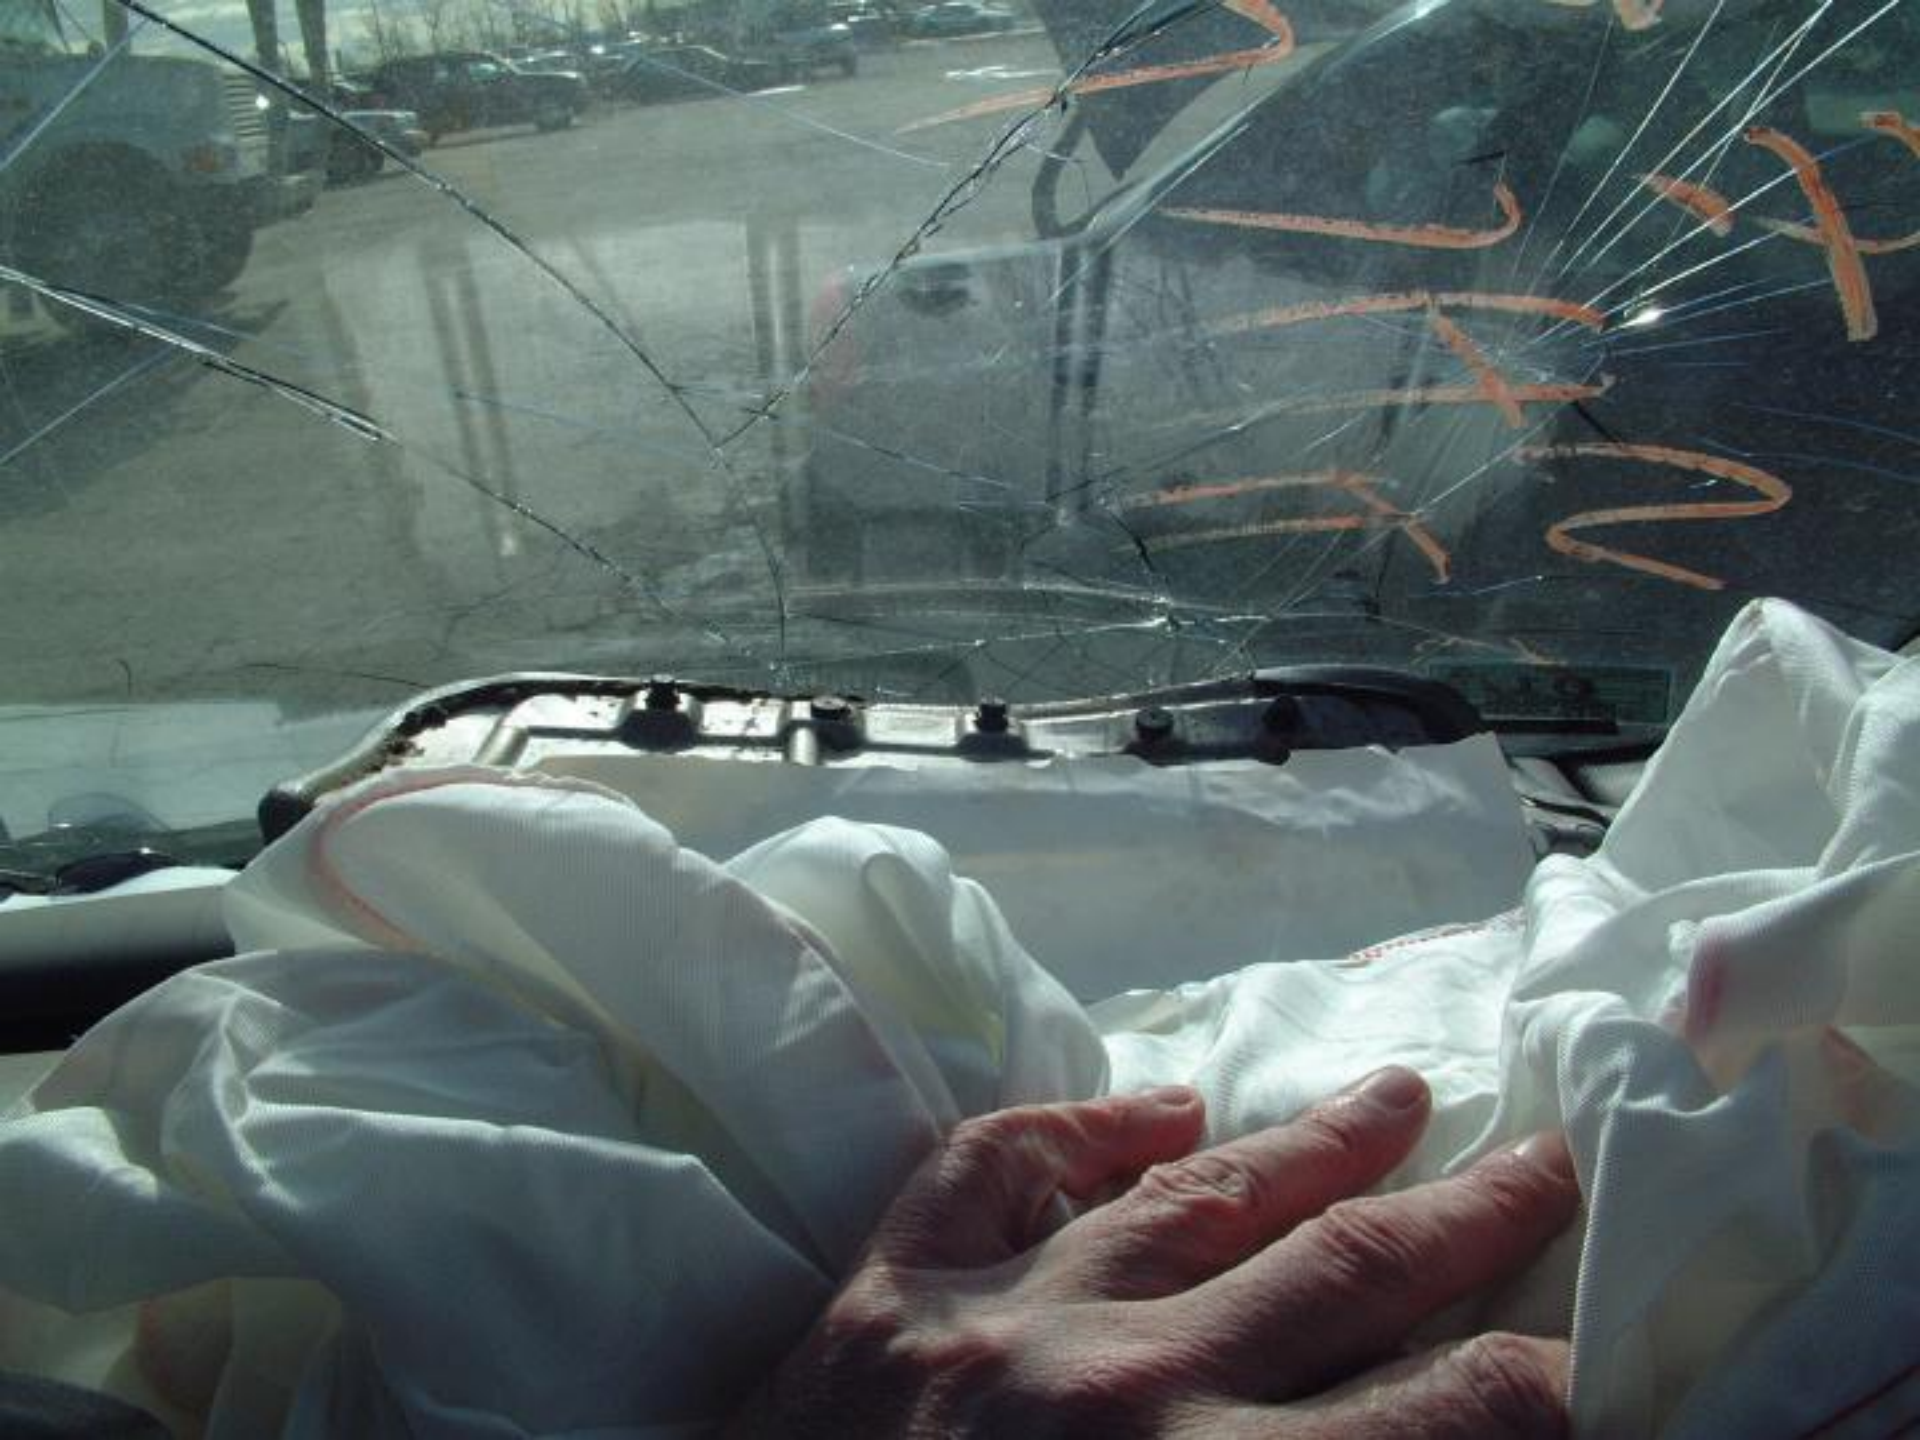
[68](#) [69](#) The 5-ft, 5-in, 200-lb, 35-year-old female driver was using the three-point belt and the [70](#) steering-wheel airbag deployed. [71](#) Webbing imprints on the D-ring indicate belt use at the time of the crash.

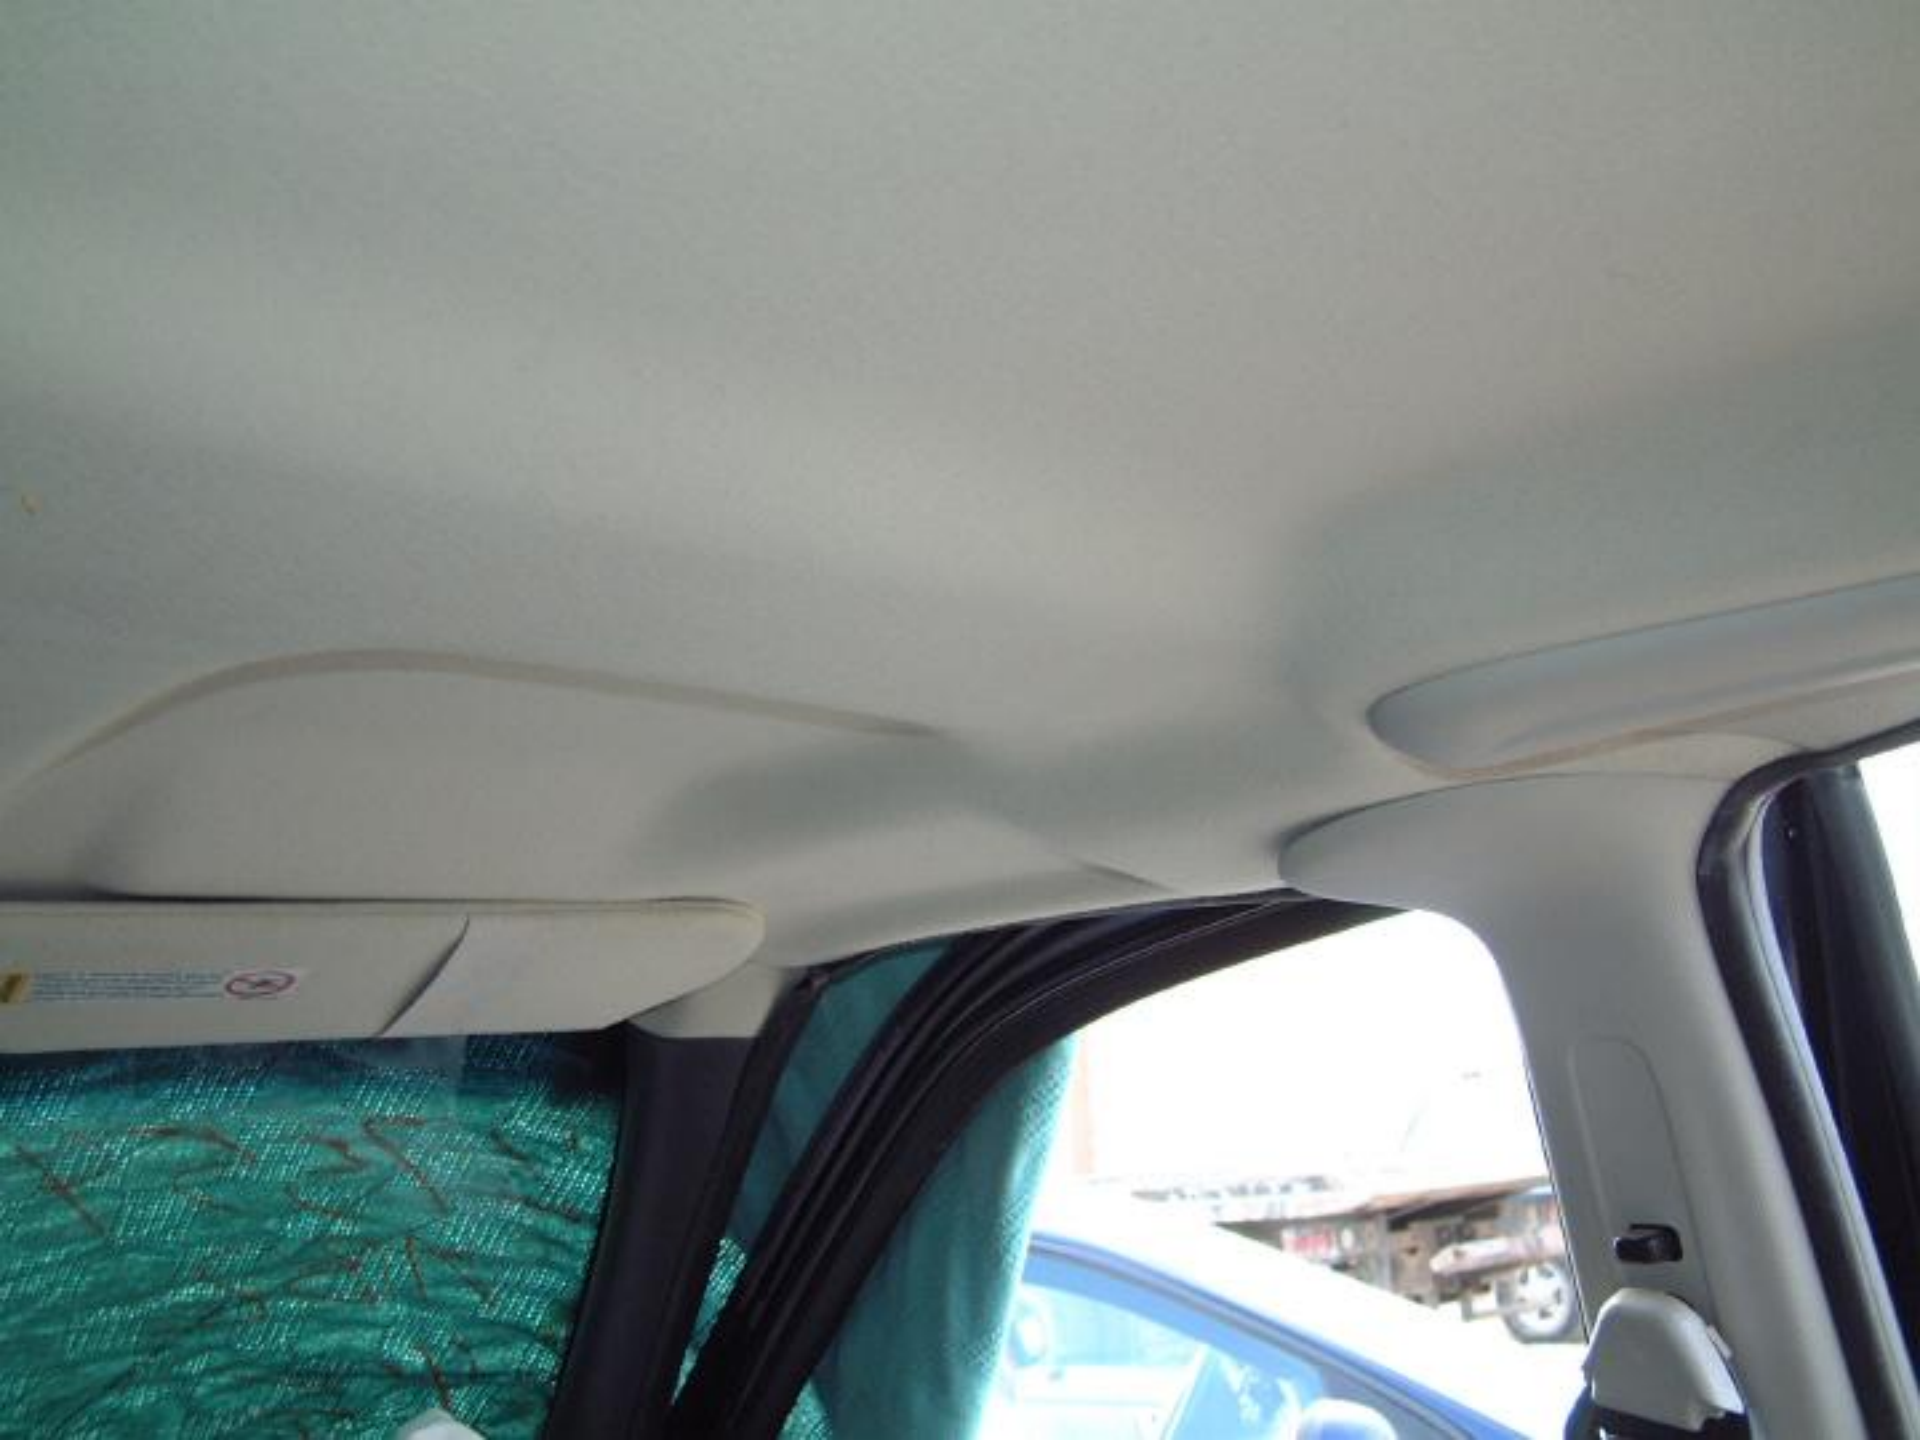
malleolus, probably due to foot contact with the toepan/floor, or possibly from contact with the brake pedal, [74](#) as evidenced the deformed and deflected pedal.
